BAT USE OF HIGHWAY BRIDGES IN  
SOUTH-CENTRAL MONTANA

FHWA/MT-05-007/8159

*Final Report*

*prepared for*  
THE STATE OF MONTANA  
DEPARTMENT OF TRANSPORTATION

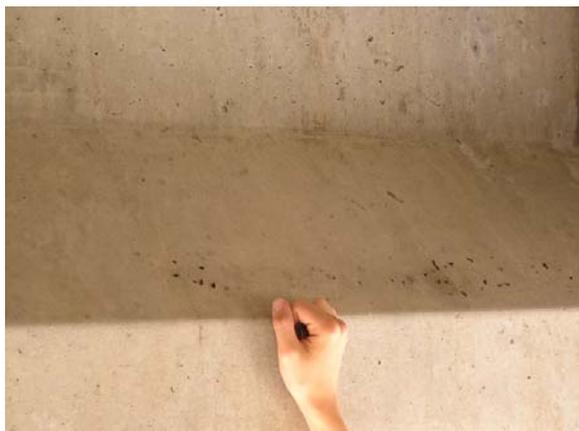
Figure 2. Droppings to the left of the hand at a concrete T-beam night roost.

General bridge surveys were conducted during daylight hours in 2003 (14-19 July, 19-21 August, 9, 12-13 and 16 September). In 2004 (7 and 10 June, 21-22 July, 26-27 August, 1 October) we focused on monitoring occupancy of the day roost structures identified in 2003. We inspected the undersides of bridges and looked for evidence of bat use especially on support beams and ledges on pillars; evidence of night roosting included the presence of droppings and/or urine staining in the absence of bats (Figures 2 and 3). We also examined crevices and

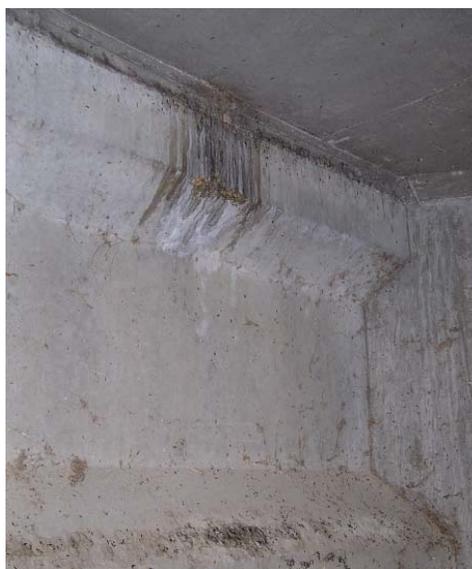
Figure 3. Urine stain on underside of a concrete T-beam night roost.

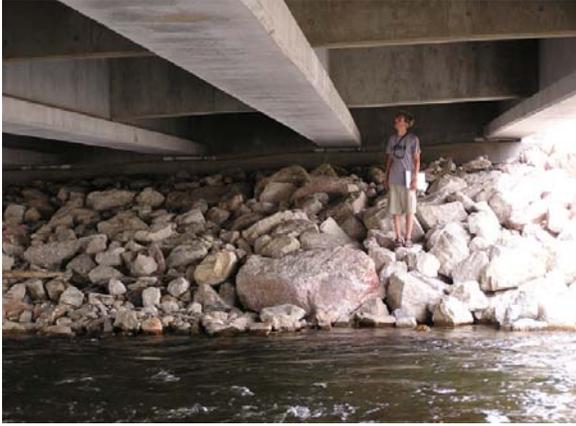
Figure 4. Concrete T-beam night roost on US 212 above Rock Creek.

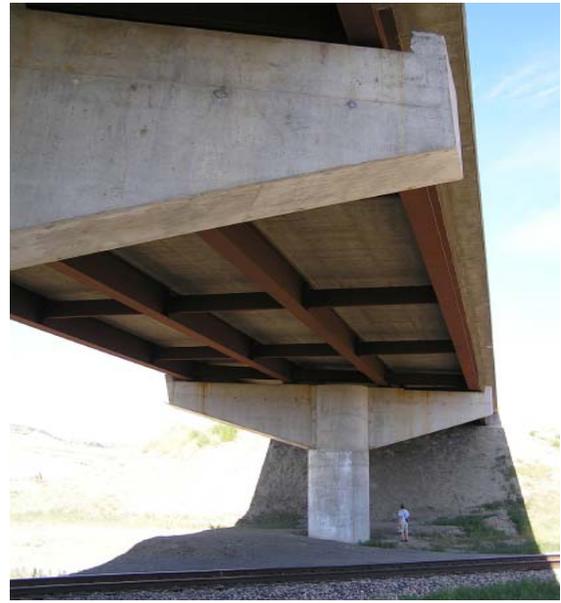
Figure 5. Steel bridge with concrete deck on Highway 310 near Warren, MT.

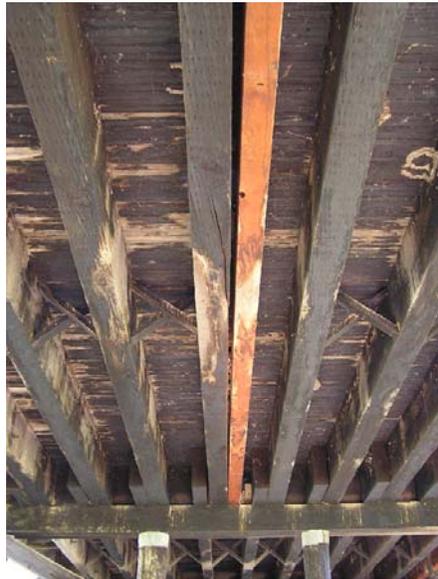
Figure 6. Wood girder bridge on State 78 near Columbus.

Three of four maternity colonies we found were in wood bridges (Tables 7-8), either between adjacent wooden girders running parallel to the deck (Figures 6-8), similar to the railroad bridge illustrated in Davis and Cockrum (10), or between two braces supporting bolted bridge railings (Figures 9-10). At maternity roosts in the latter type of site, more than one brace location was occupied concurrently (usually 5-6 out of 12). Roosting crevices provided by the wood bridges were similar to those in bat boxes (7, 31, 32), and may simulate preferred spaces bats use in trees and buildings. Wood bridges are used in other regions, but usually at relatively low frequency for reasons yet to be determined. Adam and Hayes (14) suggested that treatment of the wood with creosote may deter bats from using them, but this did not appear to be the case in south-central Montana.

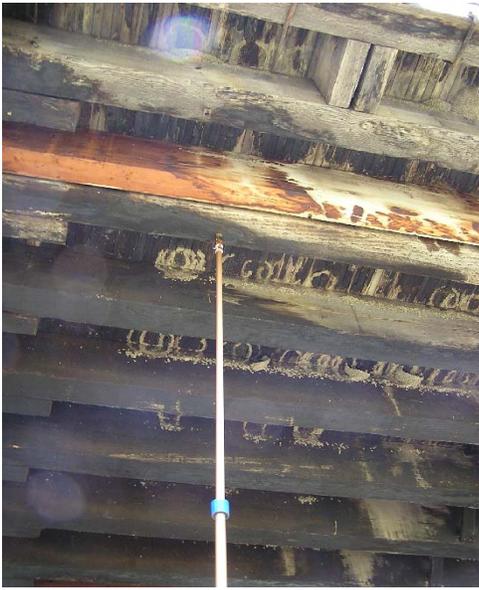
Figure 7. Maternity colony of Big Brown Bats in the slot of a wood bridge next to the pole tip, 5.3 m above ground.

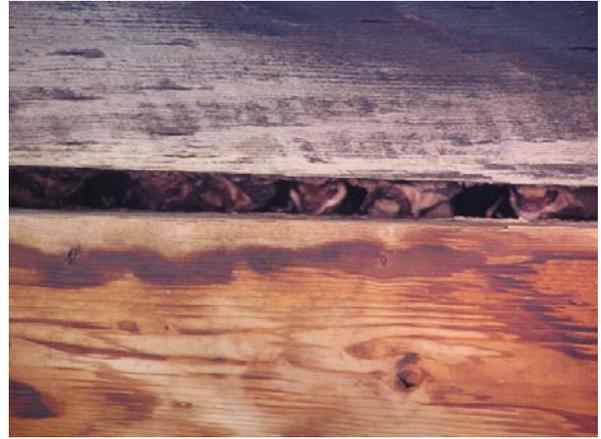
Figure 8. Maternity colony of Big Brown Bats at bridge shown in Figure 7.

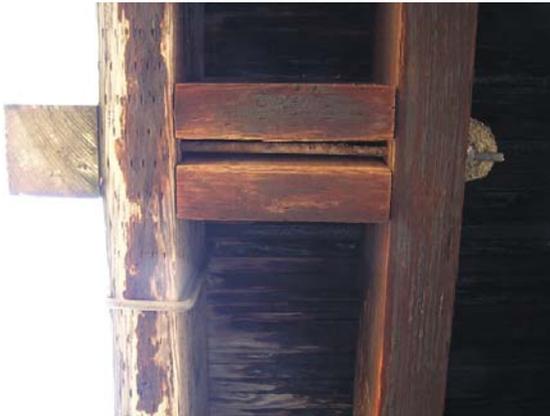
Figure 9. Site of maternity colony of Little Brown Myotis in slot between braces and behind the metal rod.

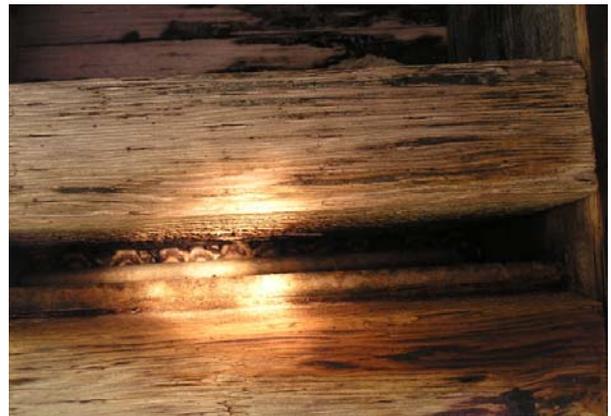
Figure 10. Little Brown Myotis maternity colony in a site like that in Figure 9, along a frontage road east of Pompeys Pillar.

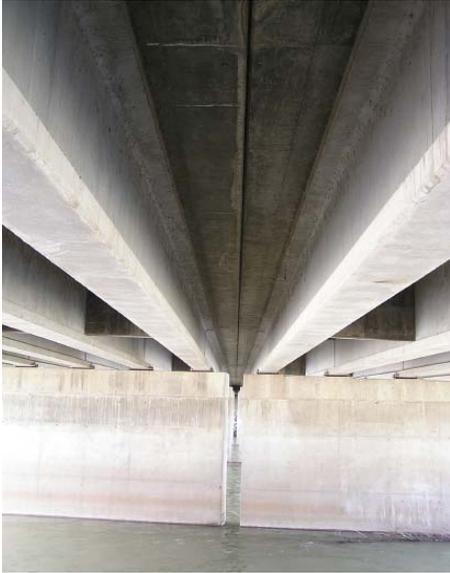
Figure 11. Day roost site between US 87 bridge spans, Yellowstone River in Billings, MT.

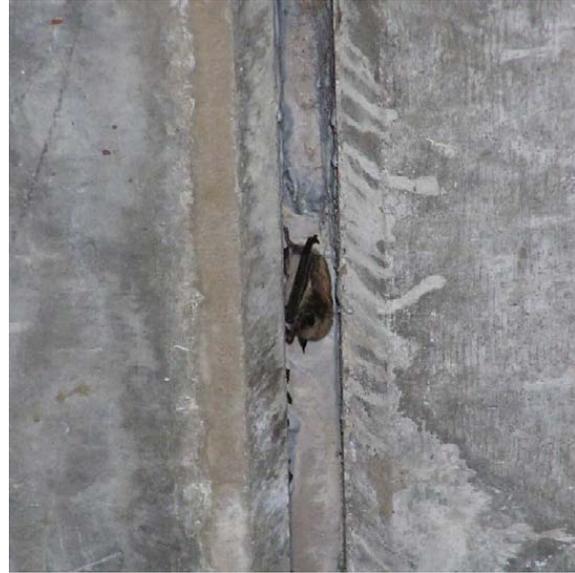
Figure 12. Occupied day roost between abutting US 87 bridge spans shown in Figure 11.

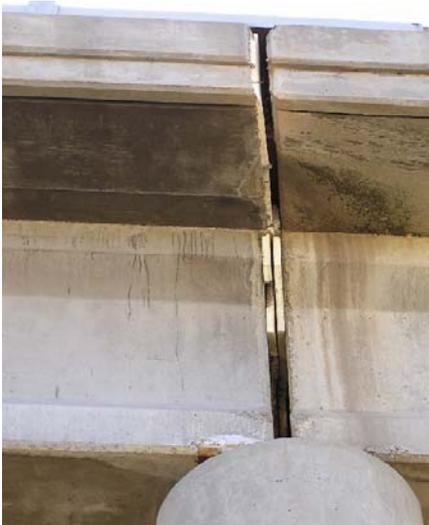
Figure 13. Day roost of Big Brown Bats in expansion joint between two concrete sections of State 306 crossing I-90; bats above the fill material.

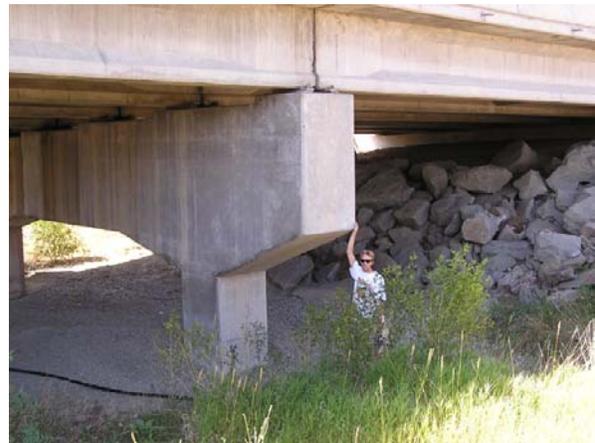
Figure 14. Day roost of Big Brown Bats in the expansion joint between two concrete sections of I-90, west bound.

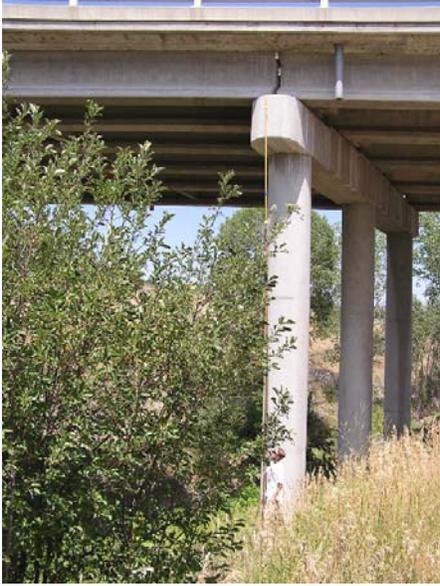
Figure 15. Big Brown Bat day roost in expansion joint of I-90, west bound, 9.8 m (32.2 ft) above ground.

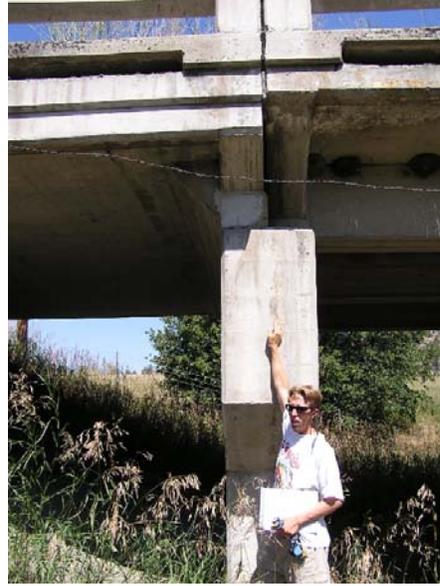
Figure 16. Big Brown Bat day roost in expansion joint of concrete bridge on frontage road west of Columbus.
